EXPERIMENTAL STUDY OF REPAIRED CONCRETE VIA EPOXY

In Partial Fulfillment
of the Requirements for the Degree
Master of Science in Civil Engineering

Georgia Institute of Technology
February 2019

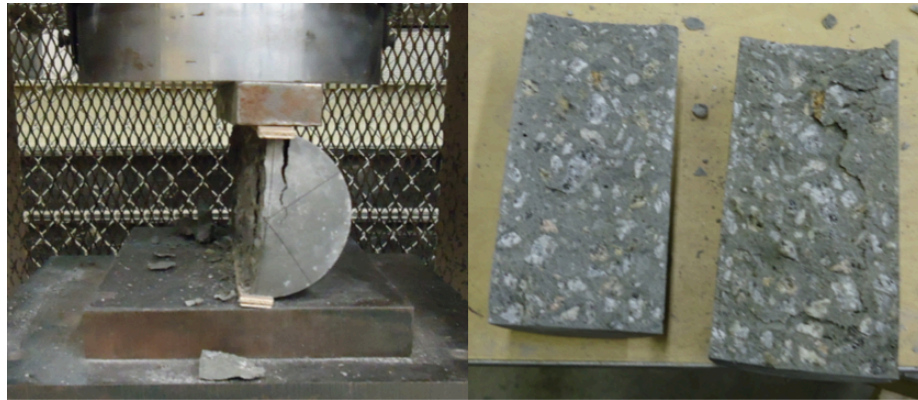
Figure 16: Undesired tensile splitting failure of initial 4 inch x 8 inch plain concrete specimen.

1,000 frames per second (fps) high-speed camera to capture quality data. From the literature, it was found that many experiments used 6 inch x 12 inch cylinders to monitor the crack growth with such cameras (Ross et al., 1996; Li, 2004). As a result, it was determined that 6 inch x 12 inch cylinders would be used for future experiments in the study in order to ensure and monitor symmetric crack propagation.

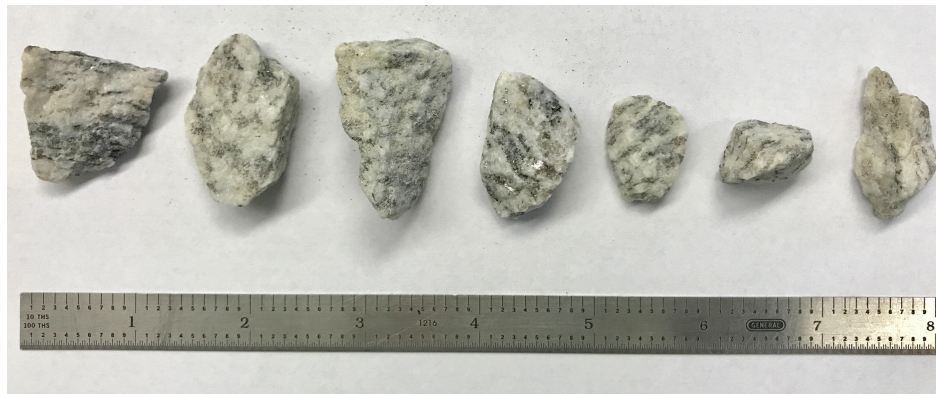
Figure 17: Granite-Gneiss aggregate used in concrete cylinder mix

Granite-Gneiss aggregates, as shown in Figure 17, can be classified as having a surface texture as crystalline, a sub-angular shape, and a low sphericity. Coarse aggregates' texture and shape can affect the presence of stress concentrations and the overall fracture mechanisms of the concrete. Therefore, scans of individual aggregate were conducted to create realistic and precise aggregate shapes for the computational models in order to facilitate better prediction of the location and timing of microcracks. A *Matter and Form 3D Tabletop Scanner*, as shown in Figure 18, was used to create three-dimensional point cloud files to generate realistic shapes of aggregate within the model. Examples of the point cloud aggregate scans from this research are shown in Figure 19.

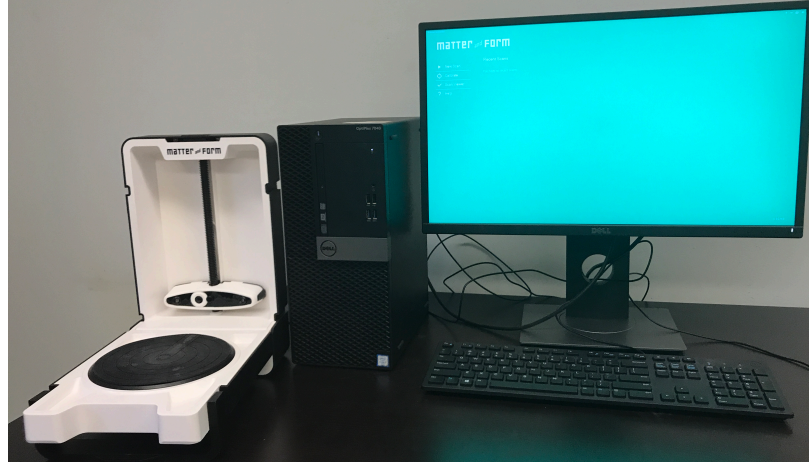
Figure 18: Matter and Form 3D Tabletop Scanner used for developing realistic aggregate models.

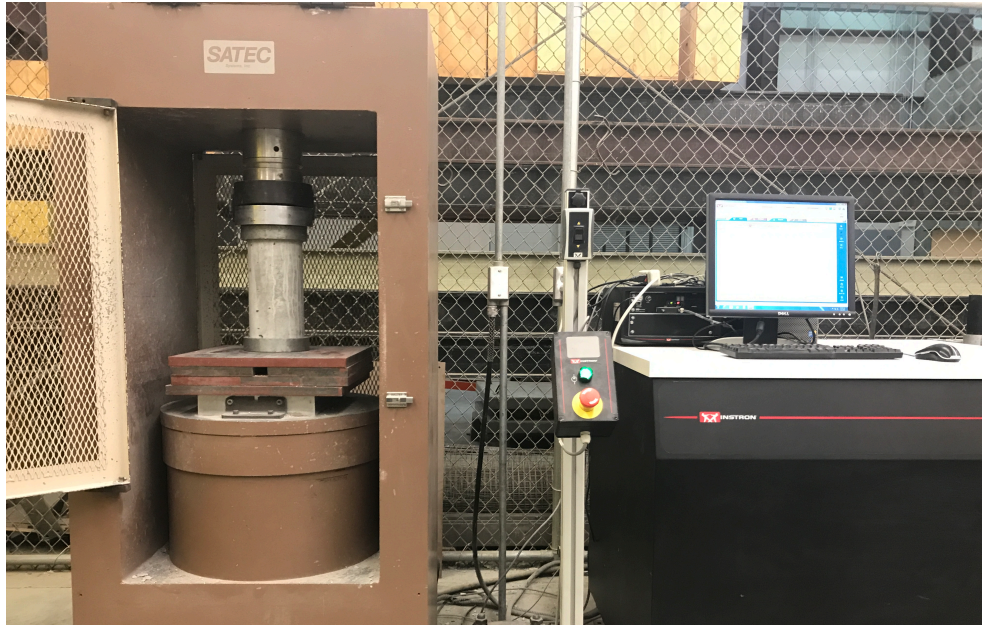
Figure 20: Uniaxial compression setup as outlined in ASTM C39.

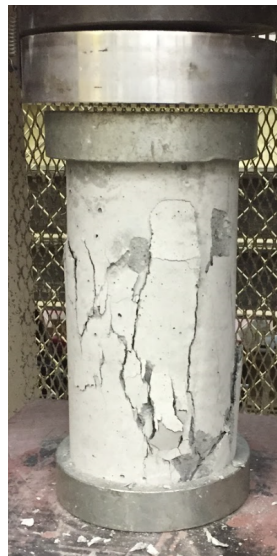
Figure 23: Typical plain concrete behavior indicative of a type 3 columnar failure.

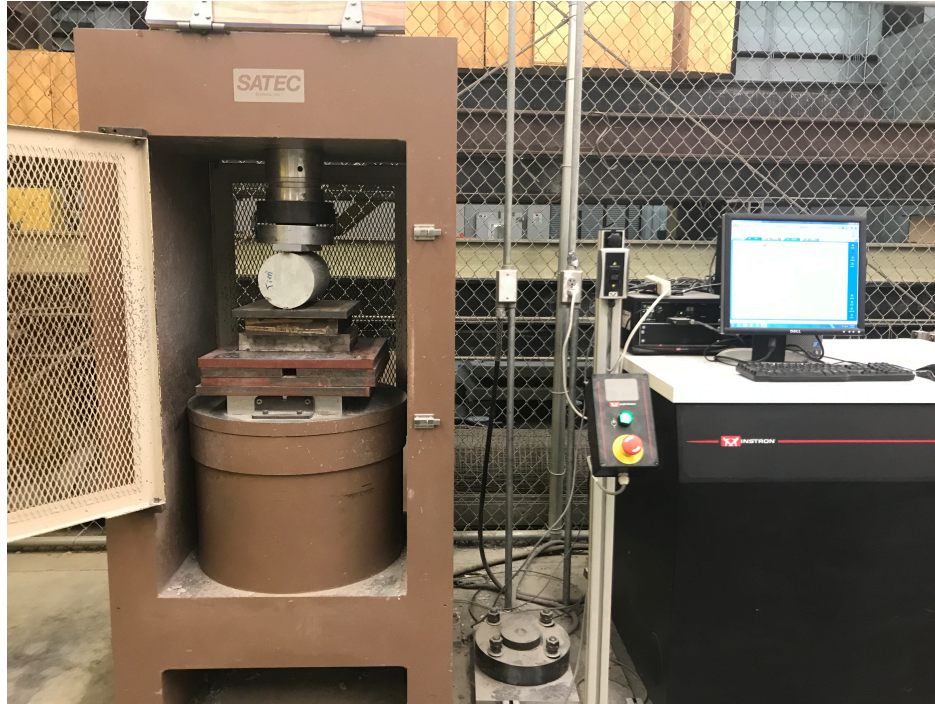
Figure 24: Splitting tension experimental setup.

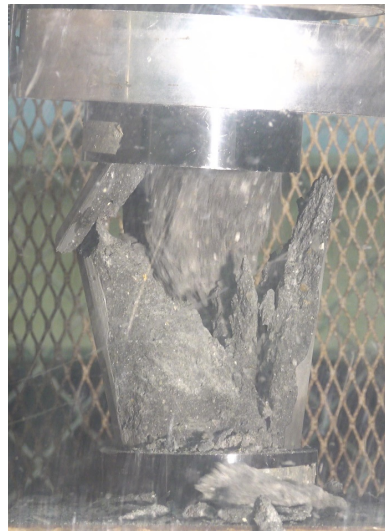
Figure 38: Typical failure pattern of mortar specimen.

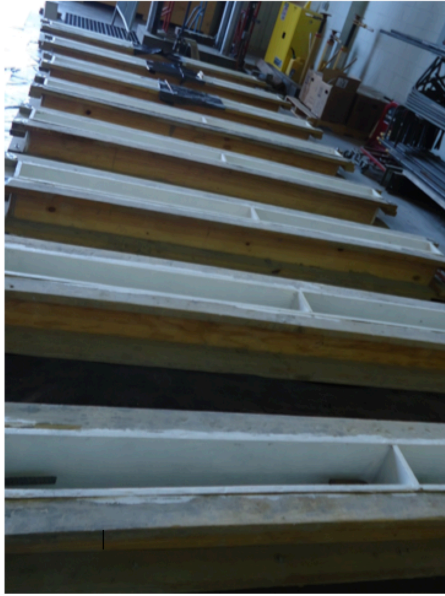
Figure 41: Concrete beam formwork.

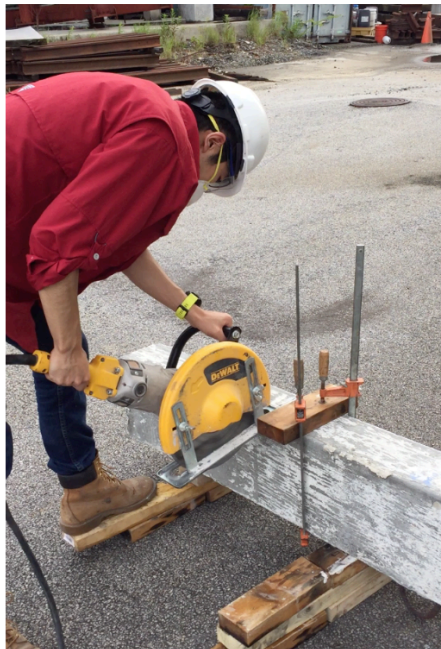
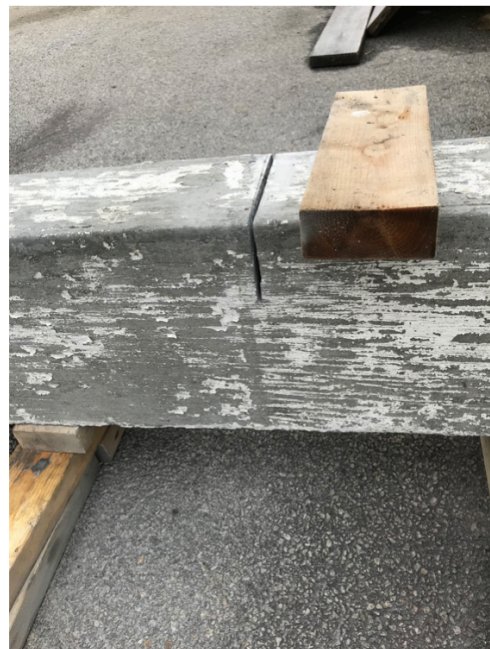
Figure 42: Notching of concrete beams with masonry saw.
